# TRUE SUCCESSES

## CORROSION INHIBITOR EXTENDS DOWNHOLE EQUIPMENT LIFE

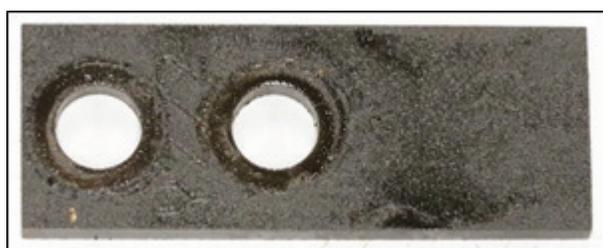
Figure 1: Top of coupon before cleaning

Coupon Position	Exposure (Days)	General Corrosion Rate (mpy)	Pitting Corrosion Rate	Pit Depth (mils)	Observations
Intrusive	289	0.07	0.0	0.0	Minor corrosion activity with minor color differences. No pitting observed.

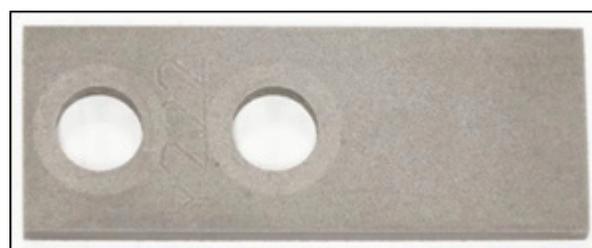
Figure 2: Top of coupon after cleaning

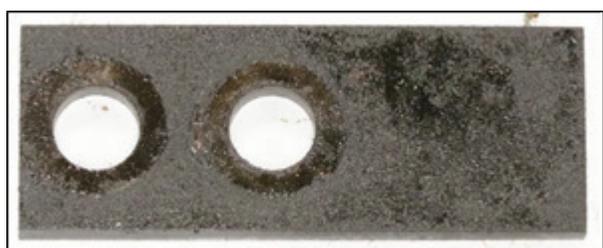
Figure 3: Bottom of coupon before cleaning

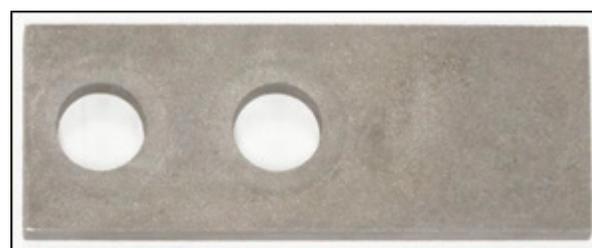
Figure 4: Bottom of coupon after cleaning
